# Technical Service Bulletin

**COMPLIANCE:** ADVISORY  
**SUBJECT:** LOWER IONIZATION DUE TO COILED HIGH VOLTAGE CABLES  
**AFFECTED UNITS:** ALL GPS-IMOD™ UNITS  
**DESCRIPTION:**

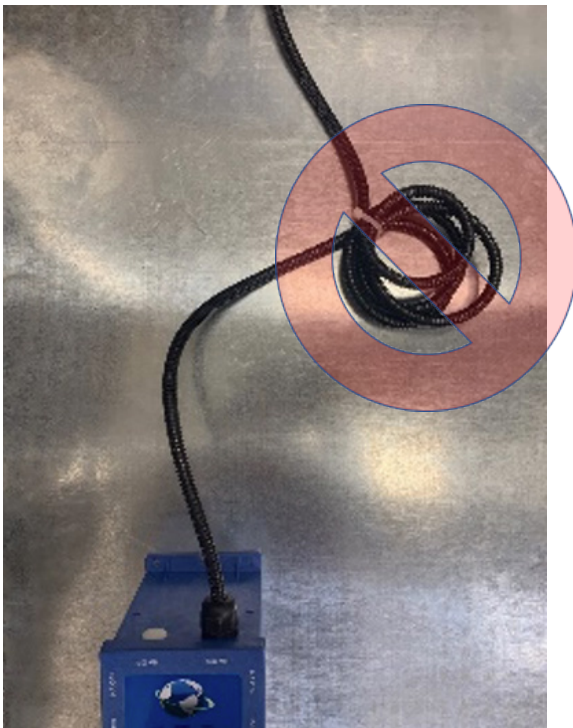
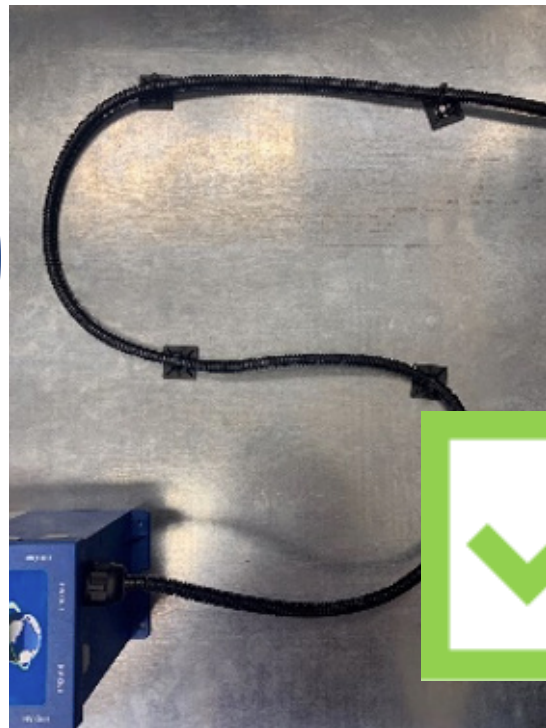
The coiling or bundling of high voltage (HV) cables can cause arcing and decreased ion output from the iMod. Installations where the cable(s) are touching in multiple locations will experience reduced output and lifespan. If the HV cable(s) is similar to the below picture, action is strongly recommended.

The proper routing of cabling is shown above.

Do not cut or alter high voltage cables. Cables 15ft long can be ordered if additional length is required. Do NOT coil, bunch, or loop the cable up so that it comes in contact with itself. To reduce slack in the cable, create long sweeping "S" shapes, like switchbacks in a road. High voltage cable should be routed with soft bends only such as creating long sweeping "S" shapes. Minimum bend radius is 3". Maximum bend angle is 70 degrees. Secure the cable(s) so they will not interfere with or be damaged by equipment or personnel.
